SUBJECT: Nortek Global HVAC Furnace Service Bulletin TB15-120A/OEM

**TO:** Aftermarket Distributors and Dealer  
**FROM:** Nortek Global HVAC Technical Support  
**DATE:** October 22, 2015  
**RE:** M7TL, M7RL and CMF95 Inline Drain Assembly

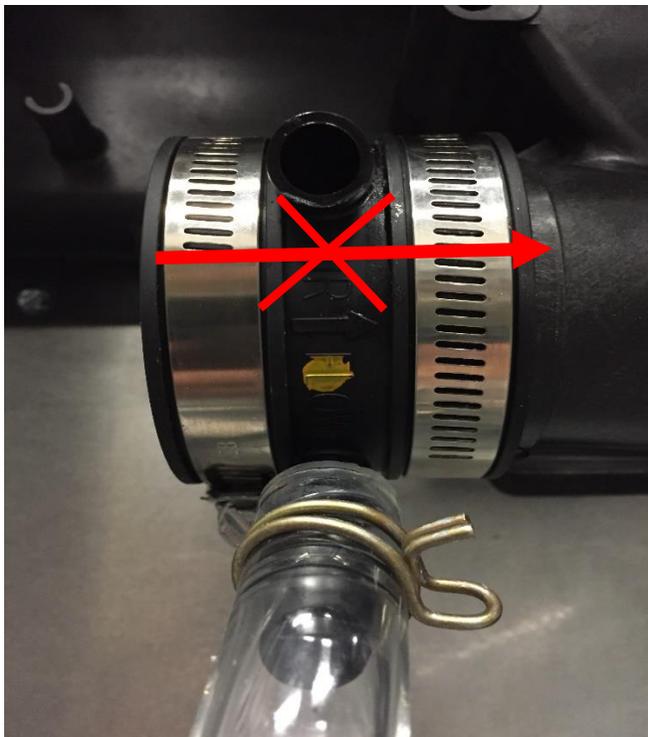
In many cases, the issue will not be apparent during initial startup, but over time water could potentially accumulate in the vent system and cause the inducer to retain water which leads to a pressure switch trip.

Incorrect: arrow on the inline drain assembly pointing towards the inducer assembly

1. Distributors with the above serial number ranges in stock, warranty will provide \$30.00 for the inspection and installation of the inline drain assembly in the correct direction.
2. If the contractor discovers the inline drain assembly error after the installation of the furnace, Nortek will pay 1 hour warranty labor plus mileage.

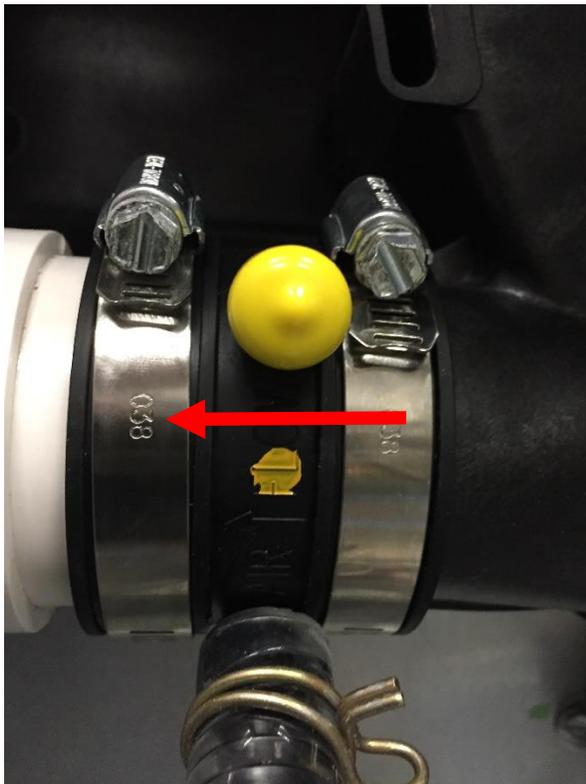
Correct: the arrow on the inline drain assembly pointing away from the inducer assembly

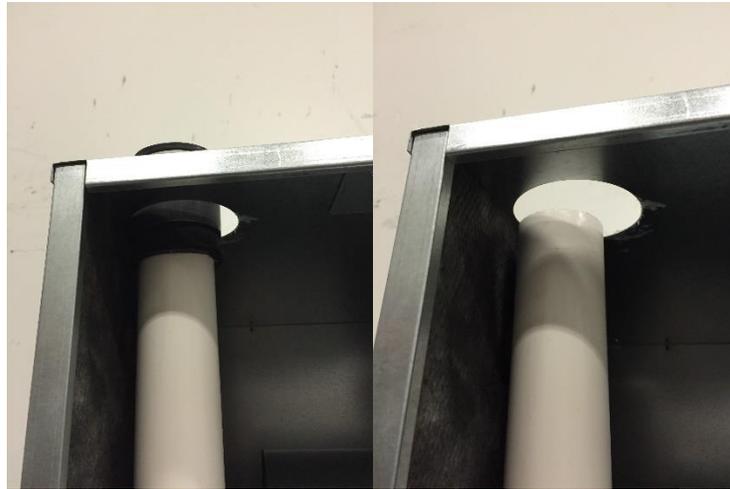
1. Remove the door on the furnace
2. Loosen the 2 clamps on the rubber coupling connecting the PVC flue going into the furnace with the rest of the flue.

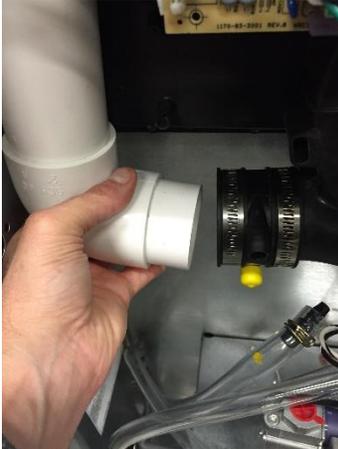
4. Remove the PVC vent from inline drain assembly.

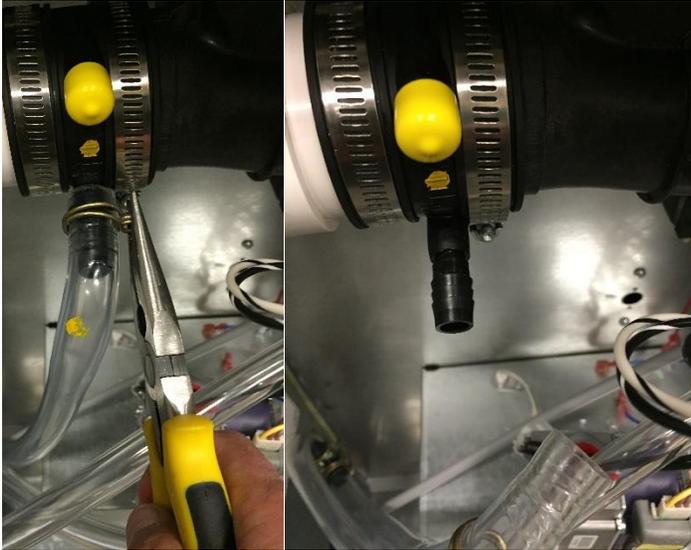
5. Pinch the clamp holding the drain connected to the inline drain assembly and remove the barbed fitting and drain tube from in the inline drain assembly.

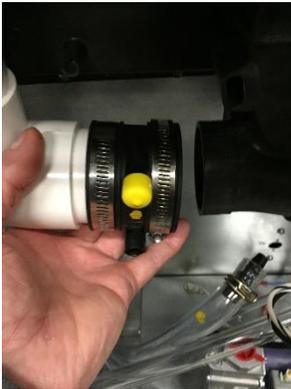
6. Remove the inline drain assembly from the inducer assembly

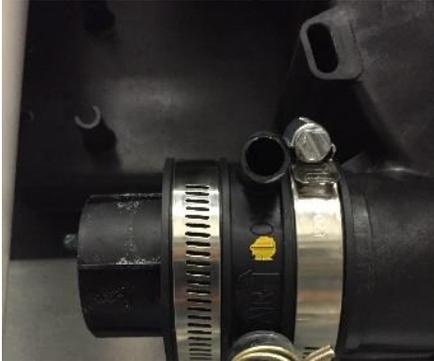
7. Reinstall the inline drain assembly on inducer, insuring that the arrow on the inline drain assembly is pointing away from the inducer assembly

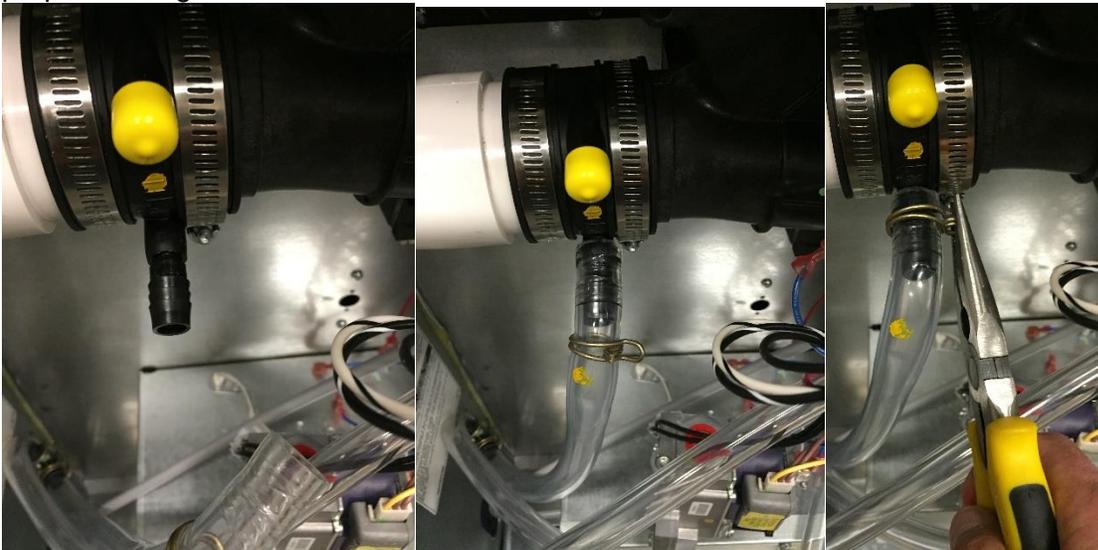
8. Reinstall the barbed fitting in the lowest opening of the inline drain assembly, then install the barbed fitting (*insure that the barbed fitting 3/8<sup>th</sup> side of the barbed fitting inserted fully in the inline drain assembly outlet*). Install the clear drain tubing on the barbed fitting and secure with the metal clamp. The outlet of the inline drain should have 10° pitch downward to insure proper drainage.

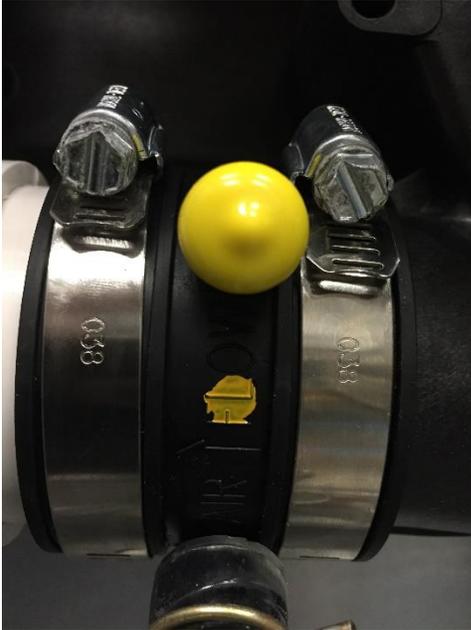
11. Tighten the clamps on the inline drain assembly using the 5/16<sup>th</sup> nut driver.
